4th Street Dam & Powerhouse Stream Bank Restoration Preliminary Site Investigation

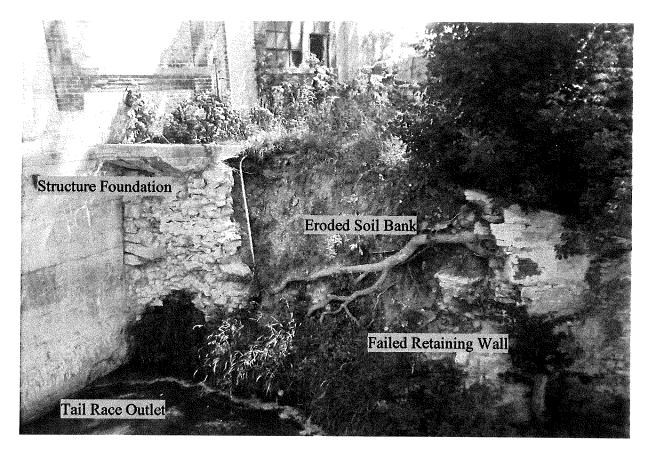
This stone/masonry retaining wall has been eroded by a strong direct current onto this area. The stone masonry retaining wall has deteriorated and is currently beyond repair. With the wall failure at this location, the diverted river current seemed to provide enough energy to erode a least 3ft deeper into the bank. Vegetation and tree roots have been exposed in this area. The tail race outlet shown is currently a calm pool of water north of the main river current.

From a surface inspection, the power house foundation wall appears to be sound and stable. Minor cracking in the concrete surface is apparent but there are not any signs of foundation movement or settlement at the surface. The surface of erosion includes a 15ft X 15ft area which includes approx. 50 cy of soil and stone masonry retaining wall erosion.

There are no indications that surface storm water has been directed or surface flow concentrated from the parking/equipment storage area to the North and East. Thus it is concluded that the principal cause of this failure is supported by the effect of the larger river current energy; placed at this point, during the dam repair river channel diversion in 2009.
