4th Street Dam & Powerhouse Stream Bank Restoration Preliminary Site Investigation

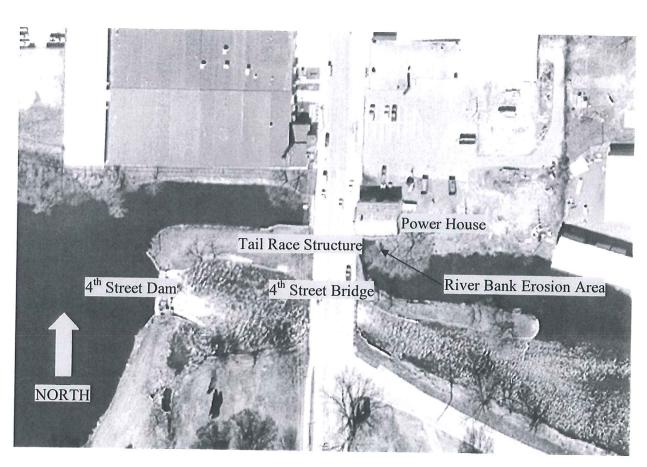
This stone/masonry retaining wall has been eroded by a strong direct current onto this area. The stone masonry retaining wall has deteriorated and is currently beyond repair. With the wall failure at this location, the diverted river current seemed to provide enough energy to erode a least 3ft deeper into the bank. Vegetation and tree roots have been exposed in this area. The tail race outlet shown is currently a calm pool of water north of the main river current.

From a surface inspection, the power house foundation wall appears to be sound and stable. Minor cracking in the concrete surface is apparent but there are not any signs of foundation movement or settlement at the surface. The surface of erosion includes a 15ft X 15ft area which includes approx. 50 cy of soil and stone masonry retaining wall erosion.

There are no indications that surface storm water has been directed or surface flow concentrated from the parking/equipment storage area to the North and East. Thus it is concluded that the principal cause of this failure is supported by the effect of the larger river current energy; placed at this point, during the dam repair river channel diversion in 2009.

It is recommended that a structural form of stream bank stabilization be considered for this erosion control best management practice. Figure (1) provides a detail of the use of 3X3 Rip-Rap Gabions stacked alternatively along the damaged area to provide structural protection against the erosion of the soil embankment adjacent to the power house. The gabions would be stacked as detailed and extend approx. 25ft south of the power house foundation wall. All backfill material and sloping embankment would be constructed as shown; which would provide for a stable embankment supporting the power house foundation.
